# Scraping the Bottom – From Plutarch to Polymers

**Association of Average Adjusters of the US & Canada Chairman's Presentation October 7, 2021**

**John M. Walker**

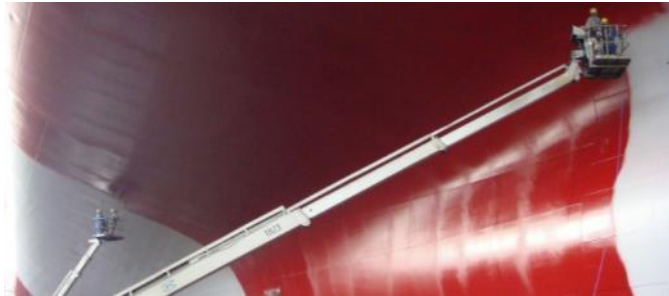
- Bottom coating removal, preparation and application of a typical Panamax bulk carrier drydocked in Asia is around **USD 1m.**

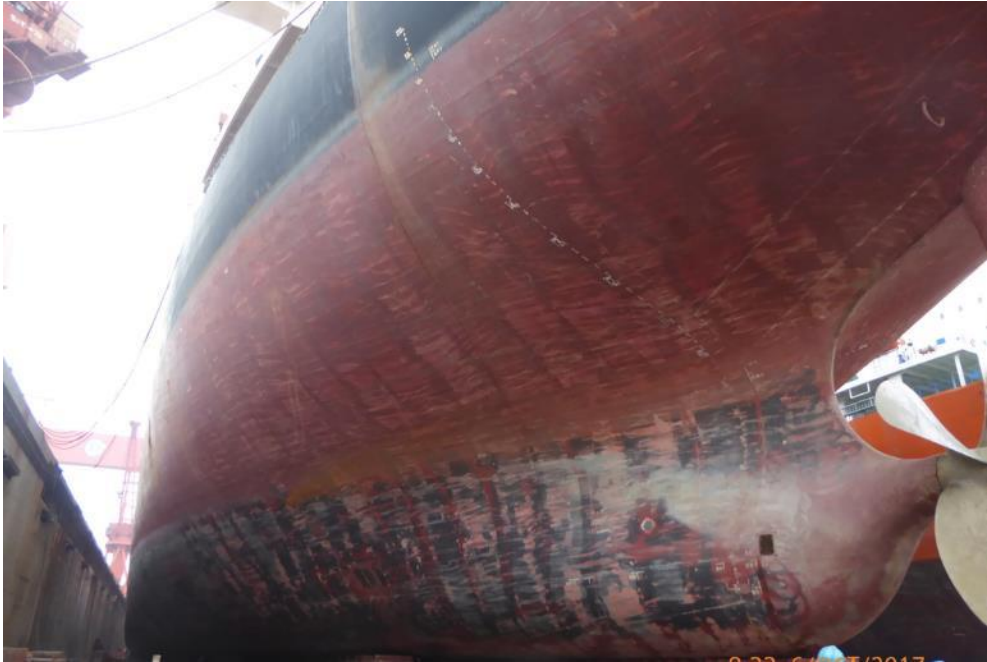
# Example of a coating system

| Intersleek <sub>®</sub> Finish (150 µm) | Intersleek <sub>®</sub> Finish (150 µm) | Intersleek <sub>®</sub> Finish (150 µm) |
| Intersleek <sub>®</sub> Tiecoat (100 µm) | Intersleek <sub>®</sub> Tiecoat (100 µm) | Intersleek <sub>®</sub> Tiecoat (100 µm) |
| | Intershield <sub>®</sub> 300 (125 µm) | |
| Anticorrosive (125 µm) | | |
| Steel substrate | | |

Hull coatings are applied as a system, rather than as just a few coats of the same product. While each paint manufacturer will have a different specification, most systems will rely on a multi-product approach of primer, anticorrosion layers, tie coat and biocide / foul release coating<sup>1</sup>.

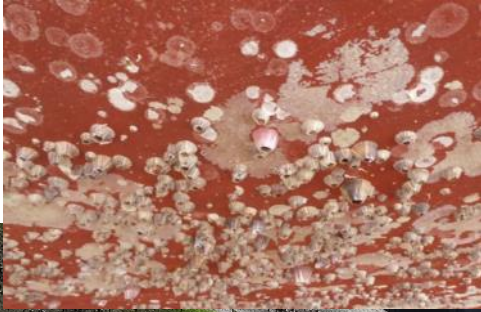
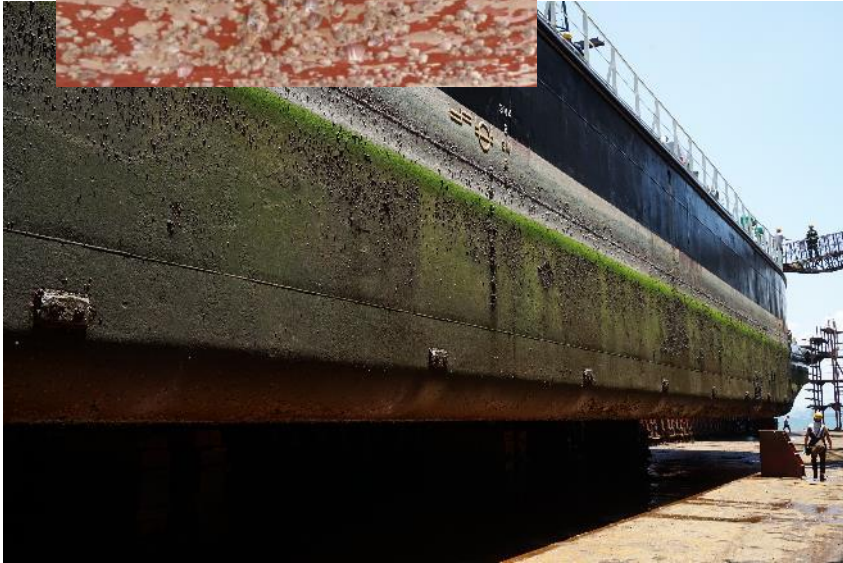
## Marine fouling

- Unwanted growth of organisms on submerged structures
- Increased hull roughness and drag
- Speed reduction
- Increased fuel consumption up to 40%
- Maintenance & Repair
- Higher CO<sub>2</sub>, SO<sub>x</sub> and NO<sub>x</sub> emissions
- Translocation of invasive species

In summary the antifouling layer will prevent the growth of marine organisms on the submerged surfaces. A failure to have an effective antifouling has both economic and environmental consequences.
